## Trawler Gaul: - Factor/event tree analysis relating to the duff chute's hinged inner cover

### Notes relating to the factor tree

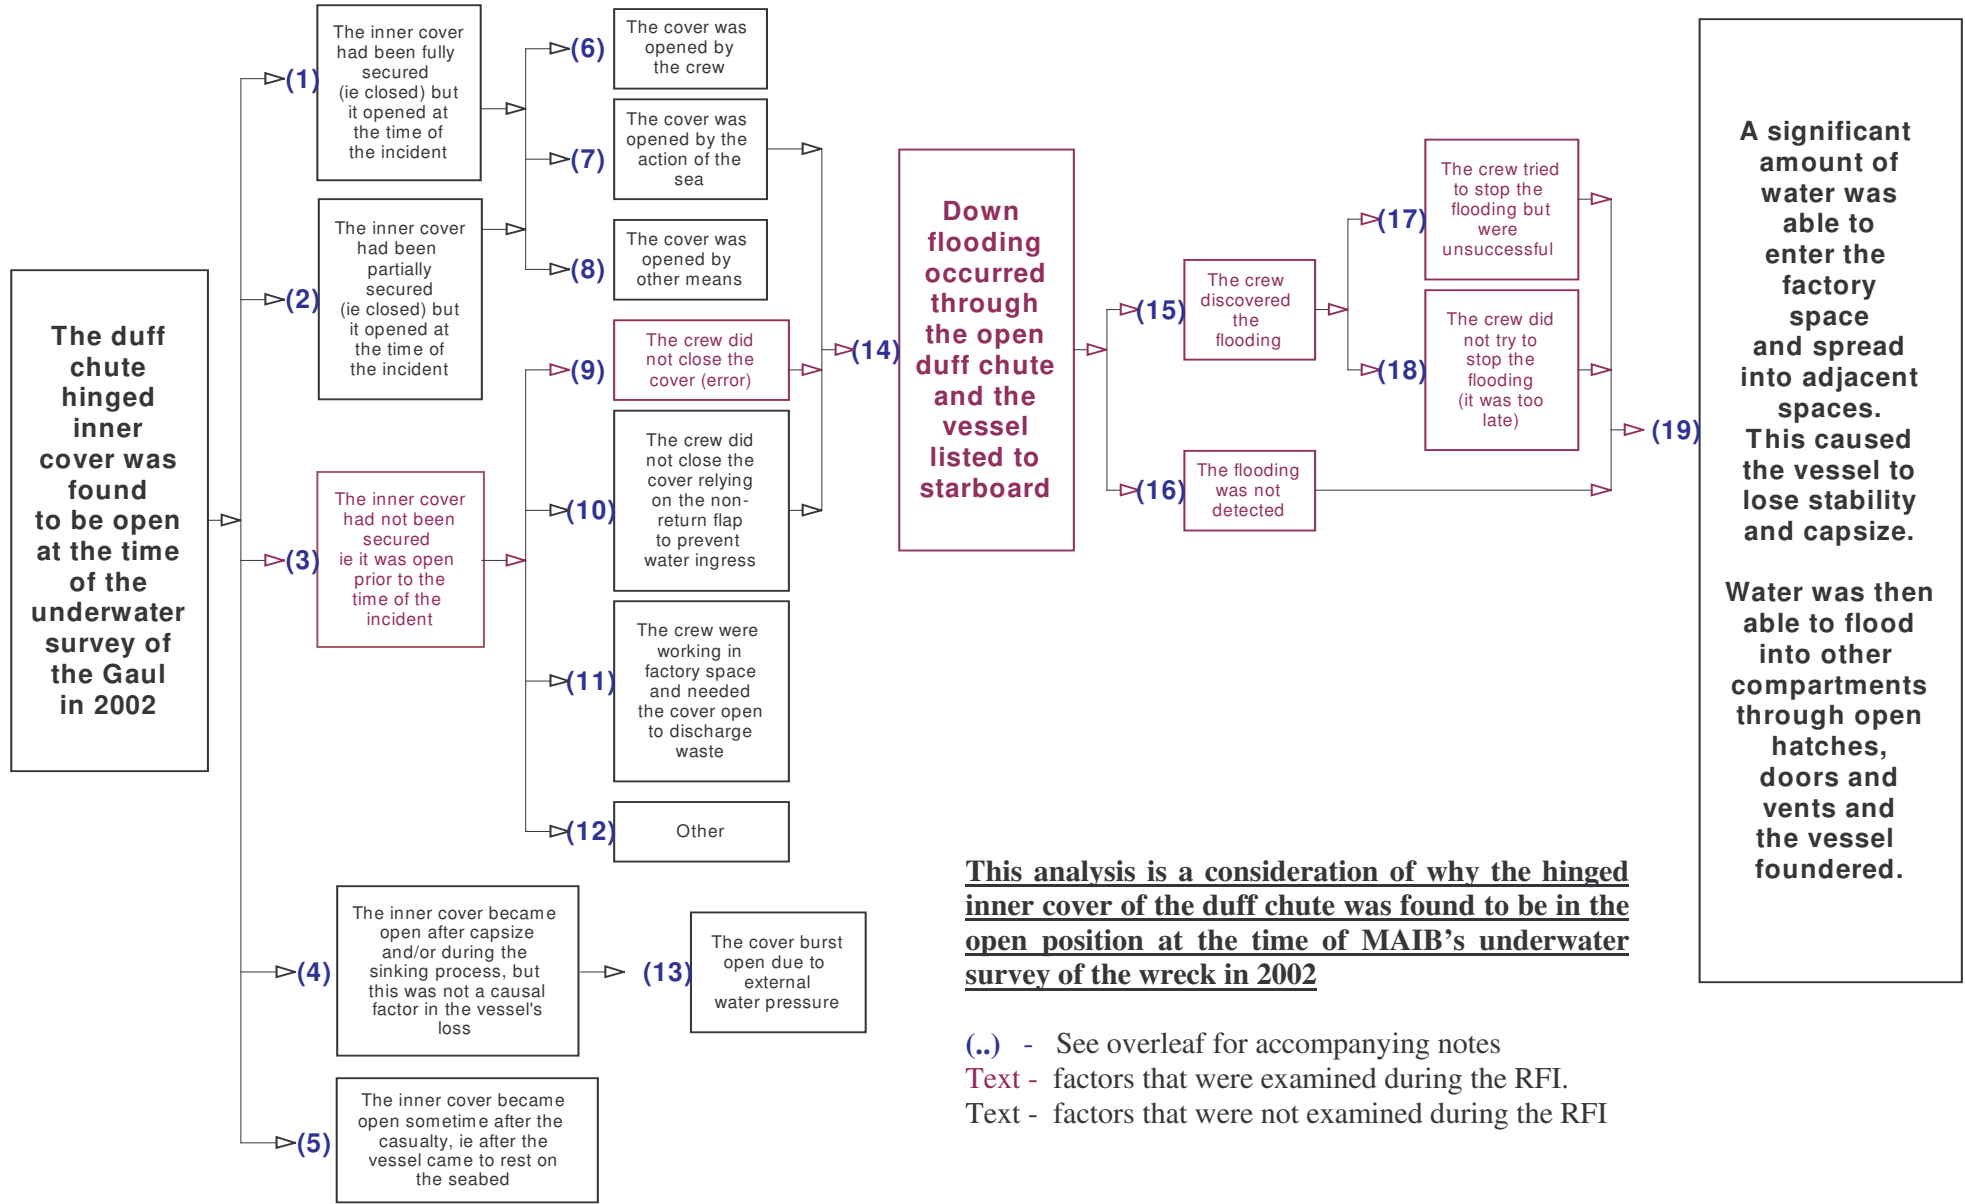
- (1) This possibility was not explored during the RFI, however the disposition of the securing toggles indicates that the cover was not fully secured at the time of the incident (*it is also possible that they could have been **fully secured** and then worked loose due to the action of the sea – a phenomenon that was highlighted during the Derbyshire formal investigation for the securing toggles on the fore deck hatch to the bosun's store*)

- (2) This possibility was not explored during the RFI. However the disposition of the toggles indicates that the cover may have been secured at the time of the incident by one of the butterfly toggles (*the toggle is not in its natural position of repose and the forked lug that it mates with appears to be damaged*). It is also possible that the cover may have been secured by more than one toggle and that they worked loose as described in (1)

- (3) This possibility was examined (*to the exclusion of others*) and was accepted as fact by the RFI, however the arguments that were put before the court, to justify this conclusion, are quite weak:

There are strong counter arguments against this possibility eg. if both the non-return flap and inner cover were open, literally tonnes of water would enter the factory space every time an unfavourable sequence of vessel motions and external waves coincided - the crew were unlikely to overlook this factor. Additionally the suggestion that the cover was tied back with wire is unlikely and it does not stand up to critical scrutiny

- (4) This possibility was not examined during the RFI, however there is no real evidence to support this possibility other than the fact that the cover was found to be open on the seabed (NB. A 'knockdown' and internal flooding were effectively discounted by the RFI)

- (5) There is no evidence to support this possibility
- (6) There is no evidence to support this possibility
- (7) There is evidence to support this possibility:

- i. The outer flaps had failed and were open, the sea was therefore able to act directly on the inner covers
  - ii. The inner covers were not strong enough to withstand direct sea loading

- iii. The disposition of the toggle securing devices indicated that the covers may have been forced open by the sea
- (8) No other significant possibilities were identified

- (9) The discussions in paragraph (3) are relevant to this possibility
- (10) This possibility was not explored by the RFI even though it would have been more plausible than the possibility that was put forward in (9)

- (13) This possibility was not explored by the RFI and there is no real evidence to support it other than the fact that the cover was found to be open on the seabed.  
NB. The direction of opening of the covers would mean that if they had failed due to external water pressure, they would have done so quite readily, with little apparent damage

- (14) There is evidence which supports the ‘down-flooding and a heel to starboard’ scenario
- (15) No evidence was found which supports this hypothesis

- (16) No evidence was found which supports this hypothesis
- (17) No evidence was found which supports this hypothesis, although it would be very difficult to close the cover against external water pressure

- (18) No evidence was found which supports this hypothesis
- (19) The only conclusion that can be drawn regarding the crew’s actions following factory deck flooding (14) is that this flooding was not discovered in sufficient time to allow preventive measures to be put in hand, or to allow a distress call to be dispatched.
