# The Trawler Gaul

# **Some comments on the loss of the trawler Gaul and the re-opened Formal Investigation**

**REPORT OF THE RE-OPENED FORMAL  
INVESTIGATION INTO THE LOSS OF  
THE FV GAUL**

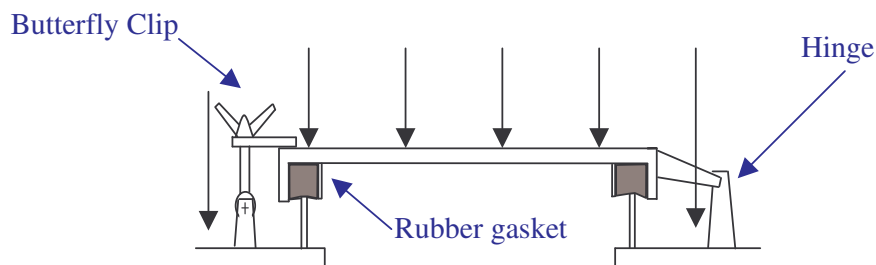
**Weathertight fitting:** In the sketch below, water pressure tends to force the gasketed steel plate into the closed position and this compresses the gasket and prevents leakage. The fitting's clips and hinges are somewhat redundant when the fitting is loaded in this way. The fitting is strong and resistant to water pressure loads from the outside:

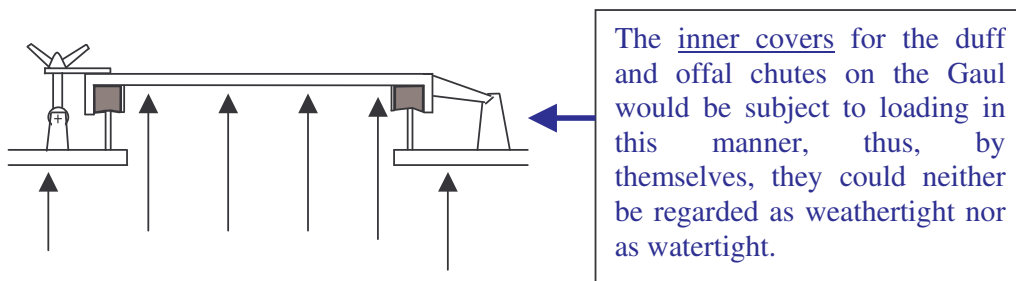
If the pressure is reversed on this same fitting, the gasketed plate will tend to lift and allow water leakage. The fitting's clips and hinges will also take the full force of the water pressure loading. The fitting is relatively weak when faced with water pressure loads from the inside:

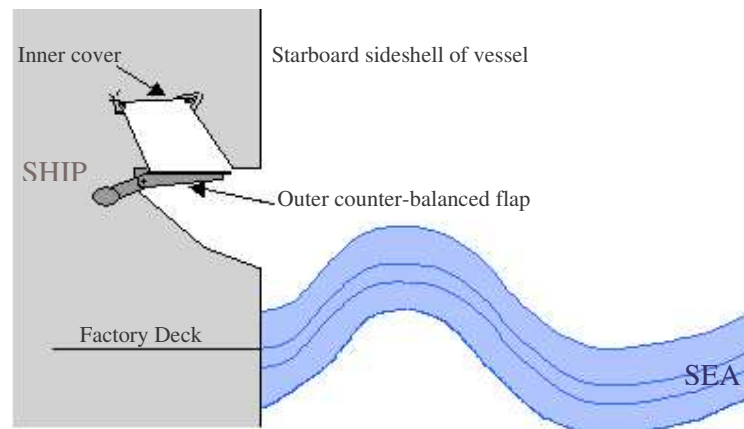
- a) Sketch showing the arrangement of the duff and offal chutes and their closing appliances: i.e. hinged inner cover with securing toggles and outer counter-balanced non-return flap both in their closed positions:

In the above arrangement, the outer counter-balanced flap provides the primary strength barrier (when it is closed) and this is capable of taking the full force of the sea. However, the non-return flap is not wholly weathertight and water can leak past this flap. The hinged inner cover, on the other hand, is not meant to take the full force of the sea (it is not strong enough) but it will prevent water that has leaked past the non-return flap from entering into the ship's factory space.

In order to assure the watertight integrity of the hull, it is necessary for both the non-return flap to be closed and for the inner cover to be closed and secured correctly.

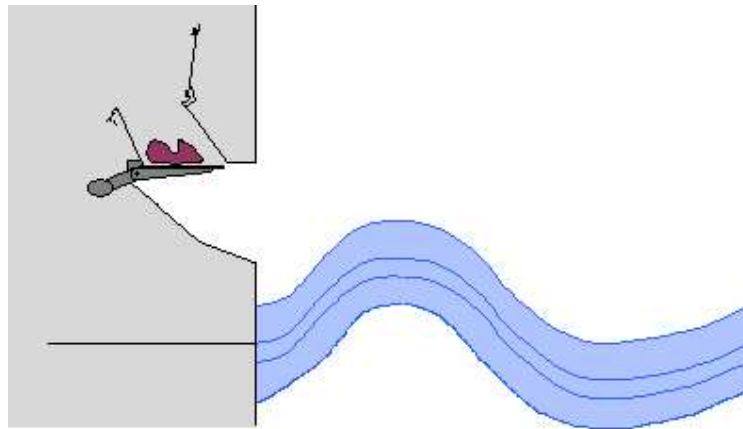
b) Sketch showing the arrangement of the duff and offal chutes: the inner cover has been opened, the outer counter-balanced non-return flap remains in the closed position and rubbish has been placed in the chute 'hopper' space:

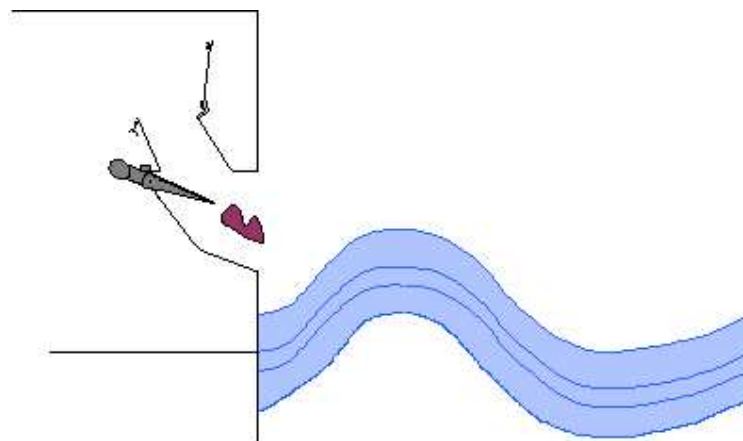
c) Sketch showing the arrangement of the duff and offal chutes: the inner cover is in the open position, the outer counter-balanced non-return flap has been opened and the rubbish is being discharged overboard:

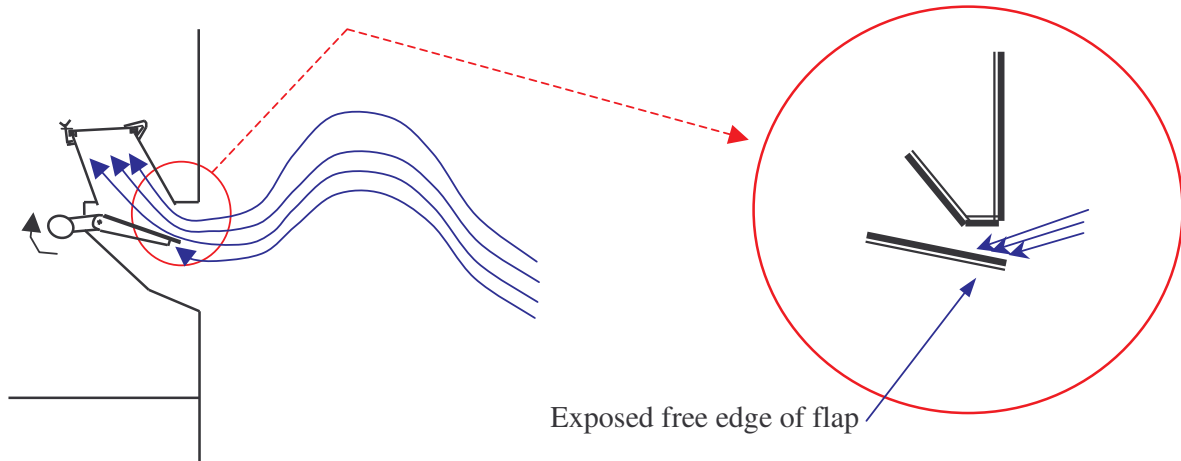
d) Considering the non-return flap arrangement that was provided onboard the Gaul:

If, for any reason, the flap was not fully closed (e.g. if an accumulation of offal remnants or stiffness in the hinges had prevented it from closing completely), the sea could act directly on the exposed free edge of the flap and push it open.

In rough weather, this could subsequently allow the full force of the sea to impact on the relatively weak hinged inner cover.

For correct 'non-return' operation, a flow of seawater into the chute should always force the non-return flap plate into the closed position. However this was not the case on the Gaul. The design of the non-return flap arrangement on the Gaul is therefore deficient and it could be expected to malfunction during normal service.

## 2.2 Considering two slightly different constructional arrangements for the duff and offal chutes, in which the design fault is not present and in which the non-return flap could be expected to function correctly:

If the position of the opening in the side shell were lowered (or alternatively if the chute and hopper construction were raised inside the factory space) so that the free edge of the non-return flap was not exposed to direct wave impact then the non-return flap would function as required.

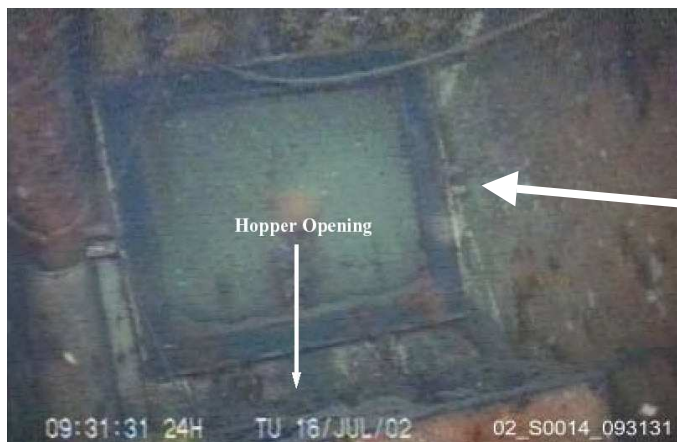
See image 1 (page 5) in the report of the investigation

Although the quality of this image is poor, one of the forked lugs on the cover, which is used in conjunction with the butterfly securing toggles, appears to be damaged (slightly spread). This would be consistent with the cover bursting open after having been secured (with one toggle) by the crew.
