MV Derbyshire - theories and factual evidence

Bulk Carriers and the Derbyshire

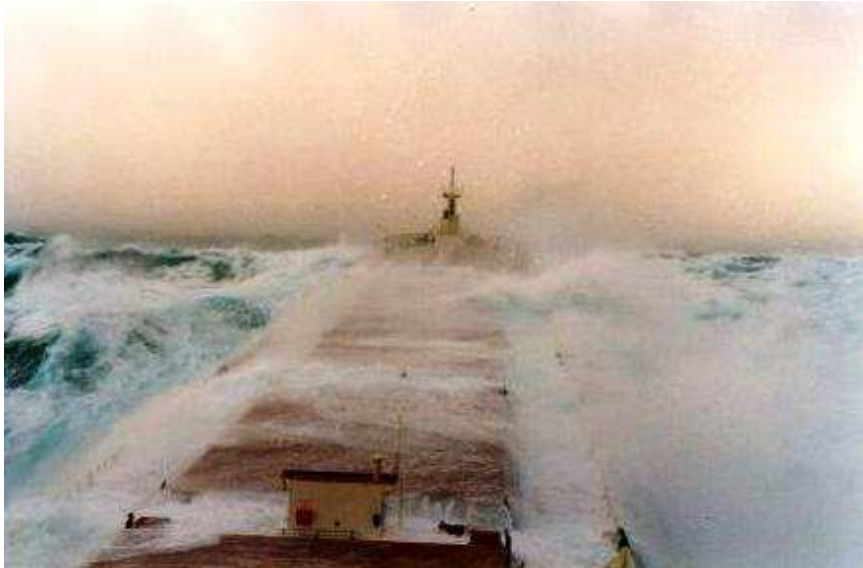
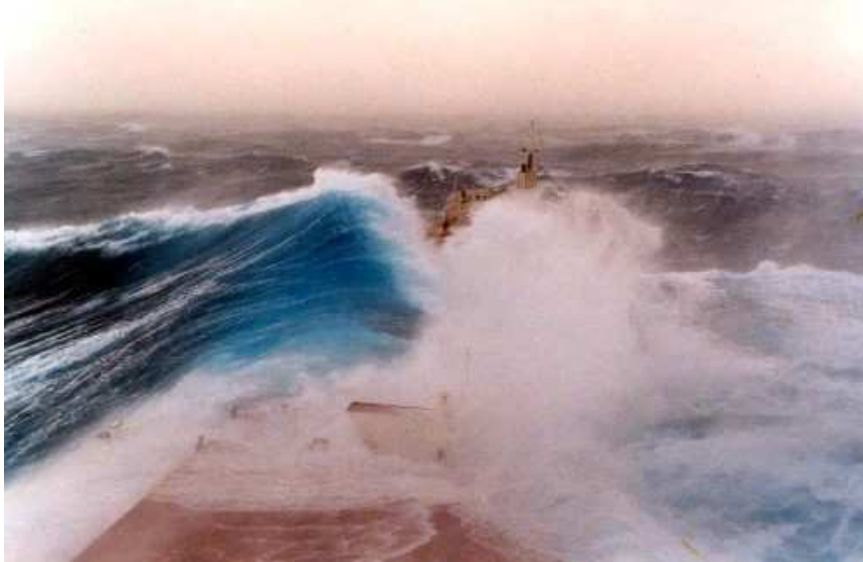
The above two images show a panamax sized¹ (60,000 - 80,000 tonnes deadweight) bulk carrier in a storm. They have been shot from the bridge, looking forward, and show

general deck wetness and ‘green sea’ loading on the number 4 and 5 cargo hold hatch covers.

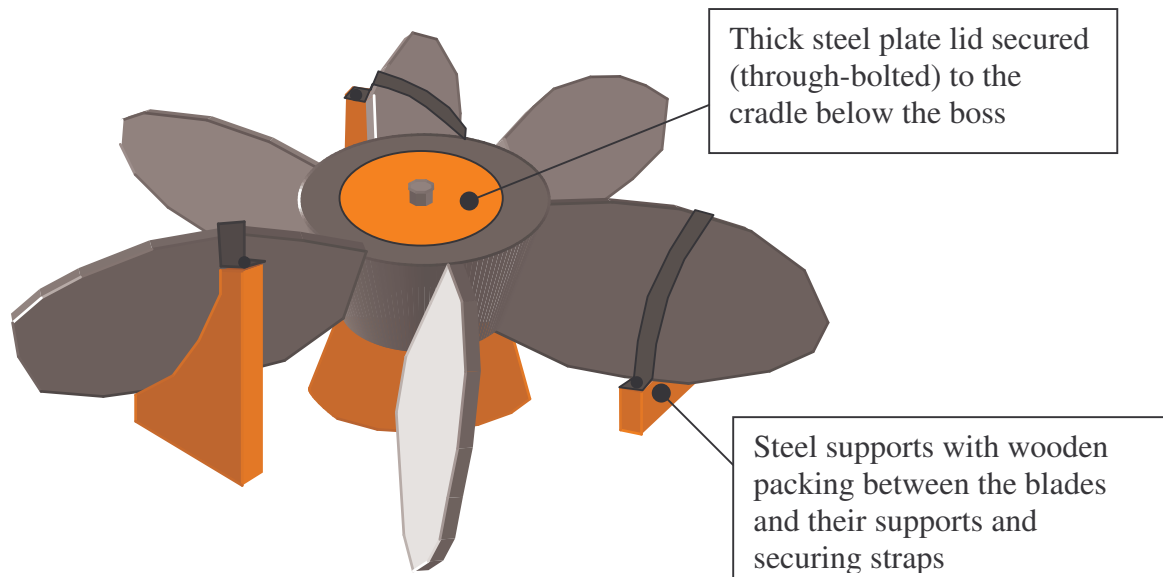
The means for securing the propeller were typical of that in contemporary shipbuilding practice: i.e. a steel cradle under the boss with additional tailored supports under three of the propeller blades, all welded to the upper deck with wooden blocks used as chocking materials between the propeller and cradle, and between the propeller blades and their supports and securing straps:

Although the above arrangement is typical and utilised onboard many ships, there were two factors in the arrangements on the Derbyshire that may not have been fully considered at the time of her design and construction:

1. The spare propeller was stowed in the forward region of the upper deck and thus would be liable to the effects of waves breaking over the foredeck (on many vessels, spare propellers are stowed in the midship area or even at the after end).
2. The propeller was stowed on the starboard side of the vessel, with the pitch angle of the outboard blades facing forward; if the propeller had been stowed on the port side of the vessel the pitch angle of the outboard blades would have faced aft

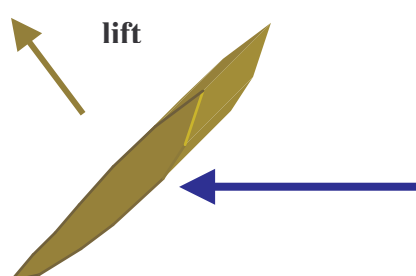
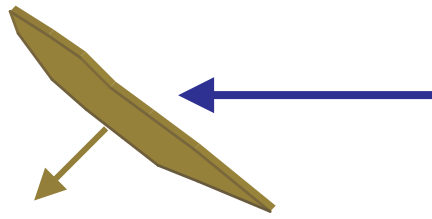
Sections through the propeller blade in way of the support and strap:

A breaking wave on the upper deck, travelling down the deck, would act upon the outer blades and cause the propeller to rotate and lift against the securing straps. (The arrangement as fitted on Derbyshire)

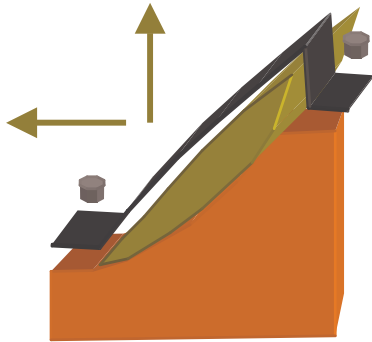
However, if the propeller had been stowed on the port side of the vessel, a breaking wave on the upper deck, travelling down the deck, would tend to push the propeller down and firmly onto its support bed

Hypothesis: Sea loading causes the propeller to rotate and lift and the securing straps to fail

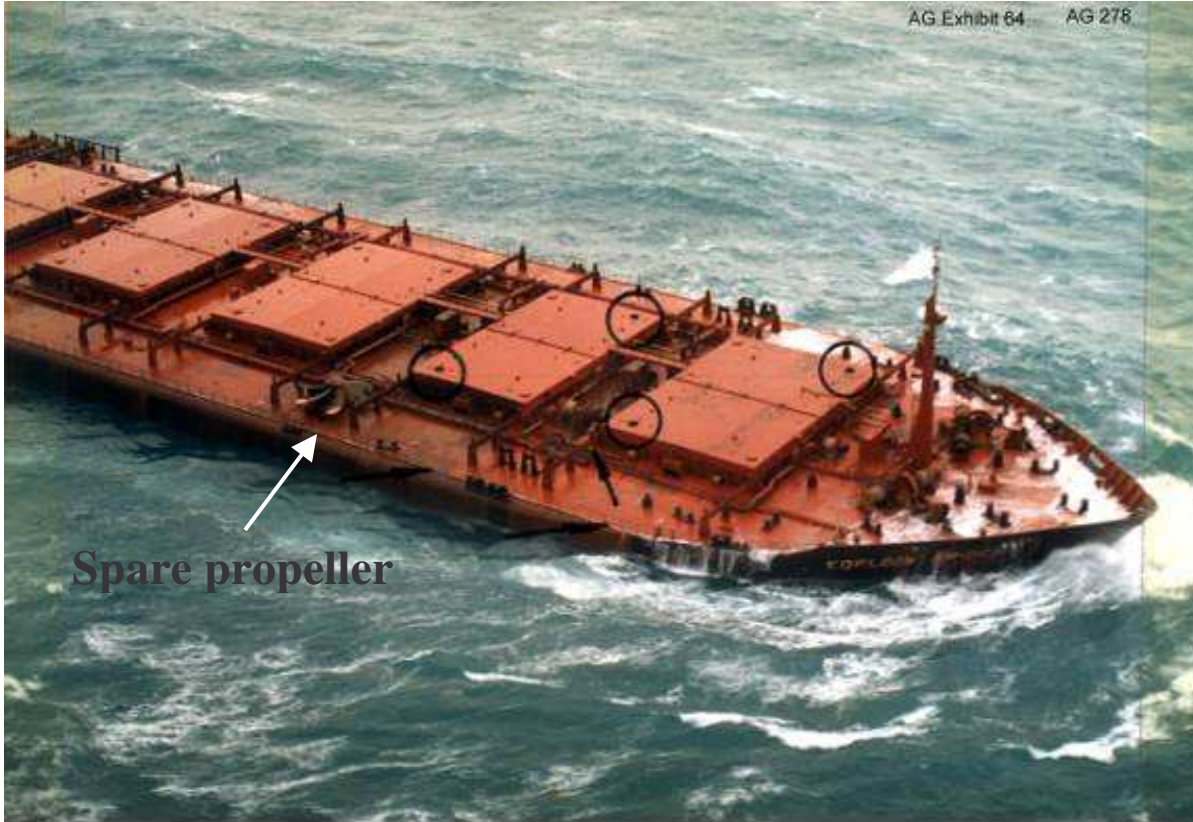
The fore deck of the Kowloon Bridge (ex English Bridge and sister ship to the Derbyshire) in the afternoon of 23 November 1986
- just prior to the vessel foundering on the Stags rocks in Irish waters

Note the condition of the spare propeller

The securing arrangements for the spare propeller can be seen to have been damaged – at least two out of the three propeller blade support straps are broken. Additionally the propeller has rotated slightly and moved off its support cradle. The broken strap can be seen more clearly in the images on the following page.

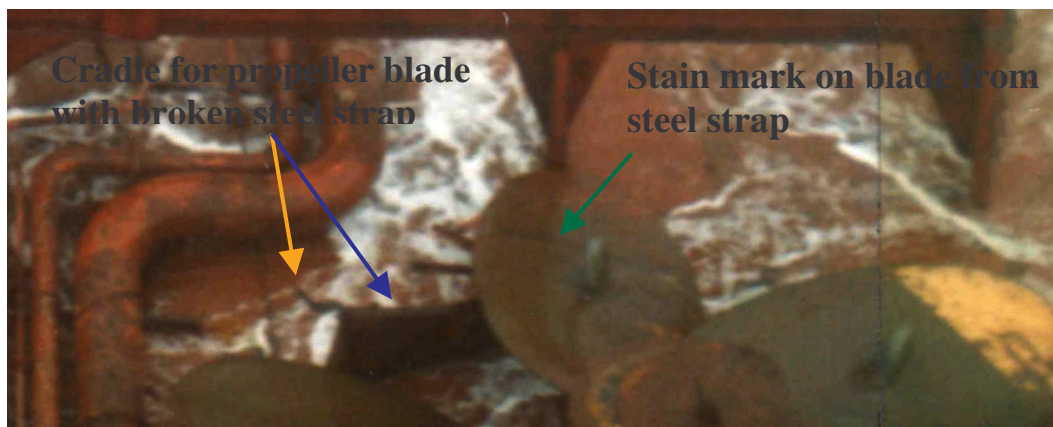
In the image below, the object (**arrowed**) is one of the support cradles for the blades of the spare propeller, a broken steel strap also **arrowed** can be seen attached to left hand side of this cradle. The propeller has obviously rotated on its supports and the strap has been broken. The dark linear **indication** that can be seen on the surface of the propeller blade is a stain mark, which shows where the steel retaining strap would have normally sat

The thick steel securing lid and the through-bolt on the propeller boss have been displaced to the right, the circular rust stain on the boss shows the original location of the lid.
