### The duff and offal chute's inner covers

### **Closed or Open?**

### 1. The duff chute's inner cover 'as found' in 2002:

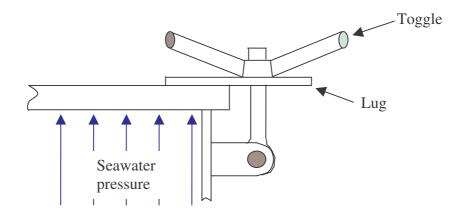
If we then consider a sectional view through the lid in way of the forked lug and toggle 'a':

If the seawater pressure exceeds the strength of the lug then the forked lug's tines will bend and open and the toggle will rotate:

Further sea loading will cause the butterfly toggle to slip down and out of the forked tines and the hatch lid will open:

If the toggle pin or its support, suffers any minor damage during this process, the toggle will tend to remain where it is rather than dropping into its position of repose.

Conclusion: The damage to the tines on the forked lug and the final position of the toggle (as observed in the underwater image) is consistent with the failure mechanism that has been described above. The evidence from the underwater image thus indicates that the duff chute inner cover may have initially been secured in the closed position by one of its toggles and that this toggle then failed allowing the cover to burst open due to seawater pressure (*The non-return flap in the lower part of the chute was open at the time of the loss and as a consequence of this fact, the forces of the sea were able to act directly upon the inner cover)*.

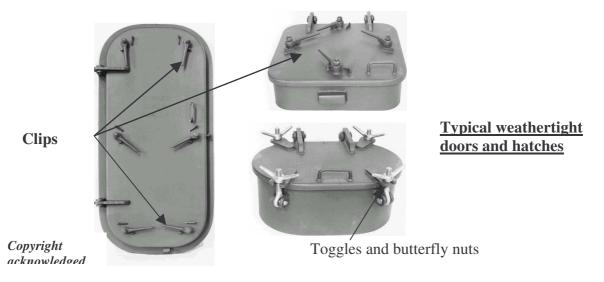
The fact that the duff chute inner cover may have been secured by one toggle only instead of all three does not indicate crew error. It is normal, in the daily operation of a ship, for the weathertight doors and hatches to be opened and closed in this fashion (using one clip or toggle only) Even in heavy weather, regardless of whether one or six clips have been used, the door or hatch cover will exercise its full strength against external sea loads and will remain closed.

However on the Gaul, the inner covers, *contrary to the norm for weathertight closures*, opened inwards and, in this respect, it was only the toggles and hinges that withstood the forces of the sea. The crew could not be expected to realise that there was this significant strength difference between the inner covers on the duff and offal chutes and that of the other weathertight hatches and fittings they would use in the normal course of their work.

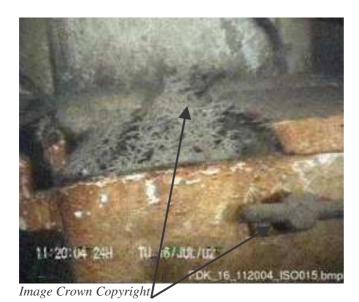
Image from inside the wreck - looking outboard towards the offal chute hopper and one of the hinged inner covers

- One of the lids is open
- The other lid is closed but unsecured
- They appear undamaged
- The strongback bar, which is essential for securing the two lids, is missing
- The two securing toggles are not in their normal position of repose (this is unusual and indicates possible damage to the toggle pins) see also the sketch on page 6

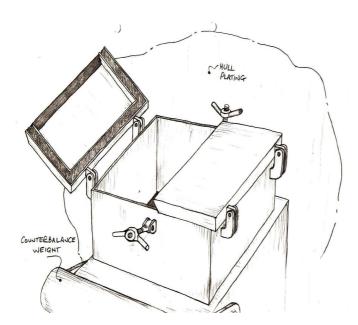
Diagrammatic sketch of the offal chute 'as found' - looking outboard

The two half covers were not provided with forked lugs, instead they were secured closed by means of a strongback bar, this was laid across the two half lids and kept in place by means of the two toggle nuts.

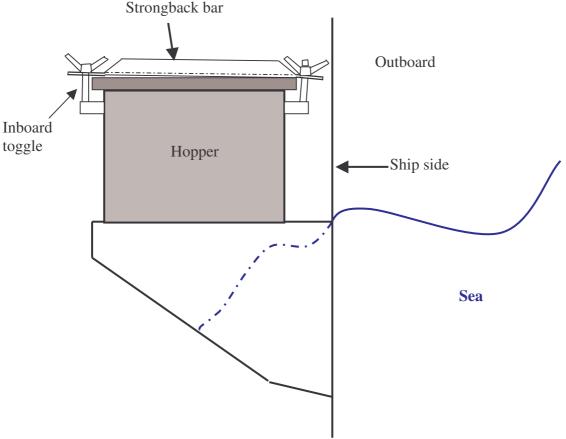
The visual evidence suggests that prior to the loss of the vessel, the covers were secured closed by the strongback bar and the two toggles, it also suggests that the innermost toggle was not screwed down fully so as to bring the strongback bar hard up against the inner covers.

This is shown in the sectional view through the offal chute hopper below:

In the sketch above the outboard toggle is engaged fully within the forked tines of the strongback bar while the inboard toggle is not fully engaged, this is illustrated in the sketch below.

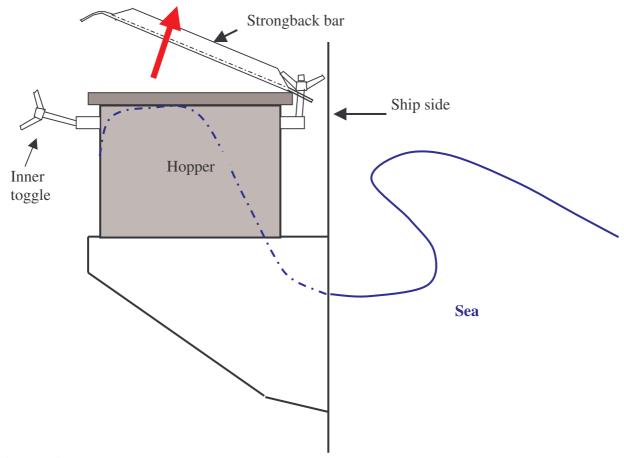
If the forces of the sea overload the toggles and strongback bar, they will fail at their weakest point. In the arrangement that is shown above, the forked tines of the strongback bar in way of the inboard toggle are the weakest point of the cover securing arrangement. The inner toggle would thus fail first, in the manner shown previously on pages 2 and 3. Thereafter the strongback bar would be 'catapulted' away from the inner covers and swept away from the chute by floodwater.

The final positions of the two toggles (as observed in the underwater image) and the fact that the strongback bar was neither attached to the toggles nor found nearby, is consistent with the failure mechanism that has been detailed above.

The evidence from the underwater image thus indicates that the offal chute inner covers may initially have been secured in the closed position by the strongback bar and toggles and that this closing arrangement subsequently failed, allowing the cover to burst open due to external seawater pressure.
