DESIGN FAULT 2

Construction of the non-return flap valves

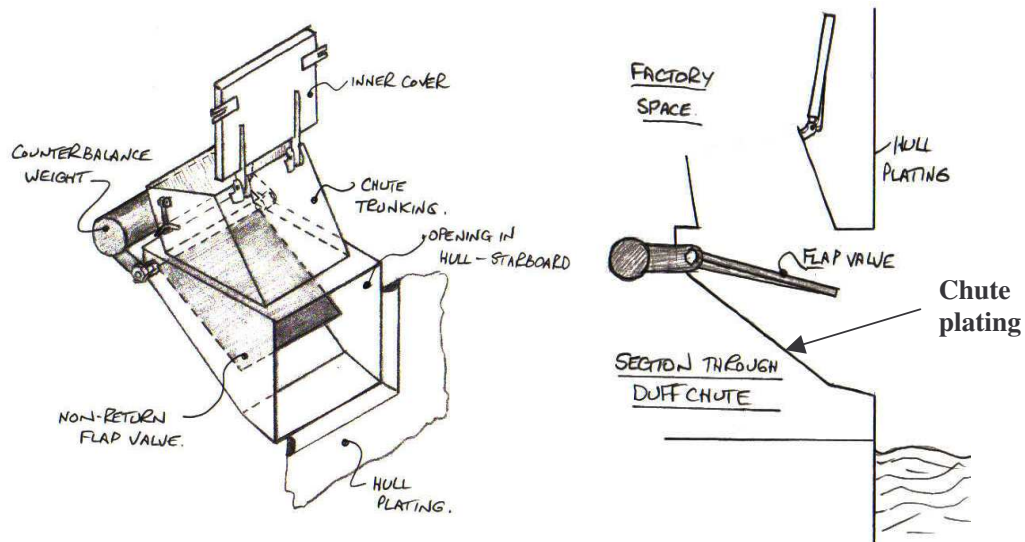
Fig 1. Arrangement of the Duff chute

The construction drawings of the duff and offal chutes indicate that the counterbalanced non-return flap, within each chute, was assembled from parts, which were bolted together. The strength and rigidity of each flap assembly was therefore dependent, to some extent, on nut and bolt clamping forces and the corresponding **friction** forces that were developed on the surfaces of the joined parts.

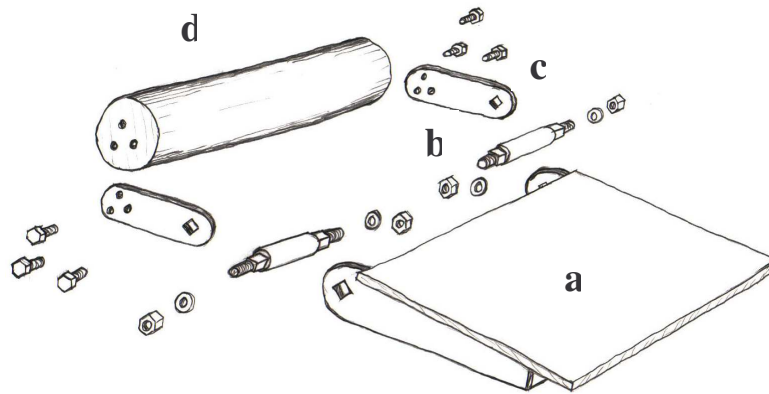
Fig 3. If we then dismantle this flap valve assembly:

Each of the holes in the above sketch (including those for the spindle square drive) would have been dimensioned to provide tolerances and clearances to their mating parts. The role of these clearances is to enable the flaps to be assembled and the spindles to be aligned within their Oilite bearings.

Comment: If the flaps are loosely assembled (i.e. the nuts and bolts are not tightened), it is apparent that the flap assemblies are **not inherently rigid** and that a certain amount of flexibility or twisting is possible until the clearances and tolerances in the boltholes are taken up.

During the initial assembly at the shipyard, this flexibility would be utilised so as to allow the correct alignment of the spindles within their bearings. After alignment, the nuts and bolts would be tightened up and the flap would become rigid; however, this rigidity would only be assured by the nut and bolt clamping forces and the surface friction forces that developed on the surfaces of the parts joined together.

Minor slippage at one of the assembly's connections (say between parts **b** and **c** in the sketch on the previous page) would result in twisting or distortion of the flap assembly and subsequent misalignment of the steel spindles within their bearings.

Misalignment of these spindles within their bearings would then be sufficient to cause the flap to become stiff, to stick or to seize.

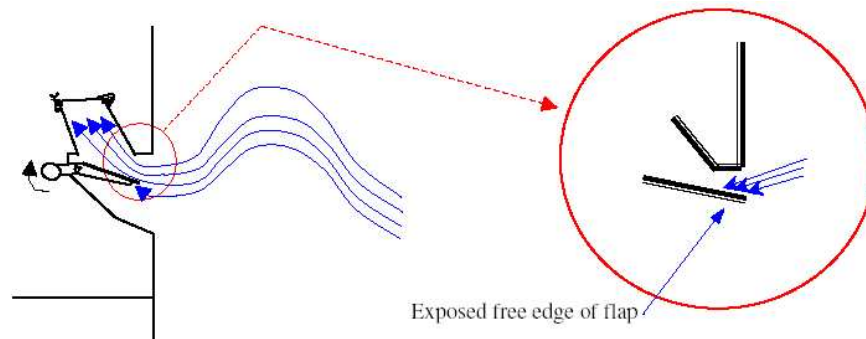
Fig. 4 section through chute

However, if, for any reason, the flaps were not fully closed, the force of the sea could act on the exposed edge of the flap and push it open.

Additionally, in heavy weather, wave loading on the flap valve plate could cause the flap plate to rotate and slam against the chute plating.

It has been calculated that the dynamic loads arising from relatively modest waves (say 5m) acting in this way on the flap plate, would be sufficient to cause slippage at one of the flap's bolted (friction) connections.
