# DESIGN ERROR 1

## The construction and arrangement of the duff chute:

### A false premise

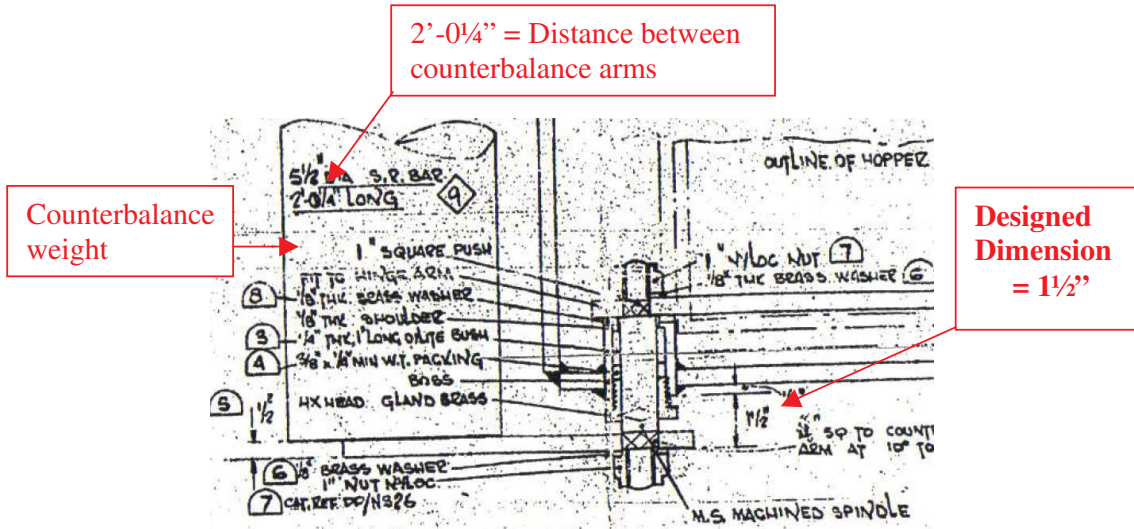
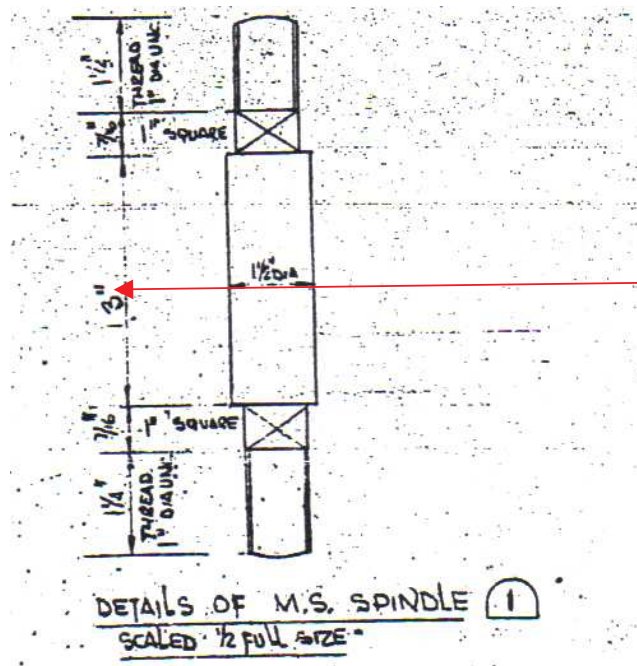
The hinge assembly

There was a dimensional error on the shipyard’s construction drawing for the duff and offal chute valve flap hinge assembly in that the length of the median portion of the spindle should have been 3¼” instead of only 3”, as the design prescribed. (for further information on this point see the part prints below and Annex 1) this dimensional error only becomes apparent when the distance between the two counterbalance arms (indicated to be 2’-0¼” on the drawing) is matched against the sum of the dimensions of the parts between the counterbalance arms and the position of the hinge spindles, which was fixed. Although the effect of this error would not have appeared as significant at the time of assembly, it would have reduced the clearance between the end of the brass glands and the steel counterbalance arms, making it insufficient.

The fact that this portion of the spindle was indicated as 3” long meant that the **designed dimension** of 1½” between the end of the boss and the outer surface of the counterbalance arm (that is indicated above) could not be achieved in practice. This part of the spindle should, in fact, have been 3¼” long.

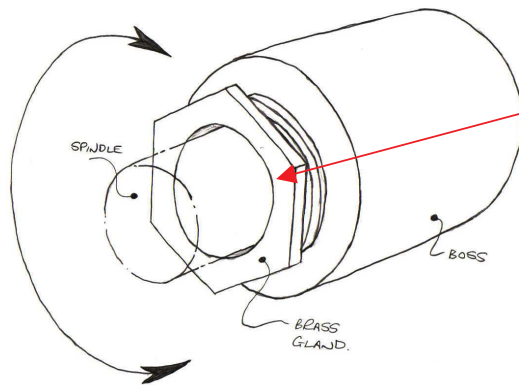
Sketch of steel boss, brass gland and steel spindle:

The brass glands within the hinges of the duff and offal chutes were each provided with a right-handed screw thread (which was normal) and this would mean that when the steel spindle was rotated, one gland would have a tendency to screw into the steel boss (to tighten) and the other gland would have a tendency to screw out from the steel boss (to loosen). It can be shown that in some circumstances the threaded brass glands on the Gaul would unscrew and, as a result of the drawing error that has been detailed previously, come up tight against the steel counterbalance weight support arms.

Various factors, such as oxide and dirt build-up or misalignment could cause the spindle and gland to bind together intermittently and, in time, cause the brass gland to unscrew (loosen).

The significance of the drawing error is that, if the brass gland were unscrewed, it would make contact with the steel counterbalance arm while still engaged in the threads of the steel boss. Further rotation would cause the gland to unscrew further and this would induce significant axial loads into the spindle, thus causing the hinge to bind and the non-return flap to stick in an open position.

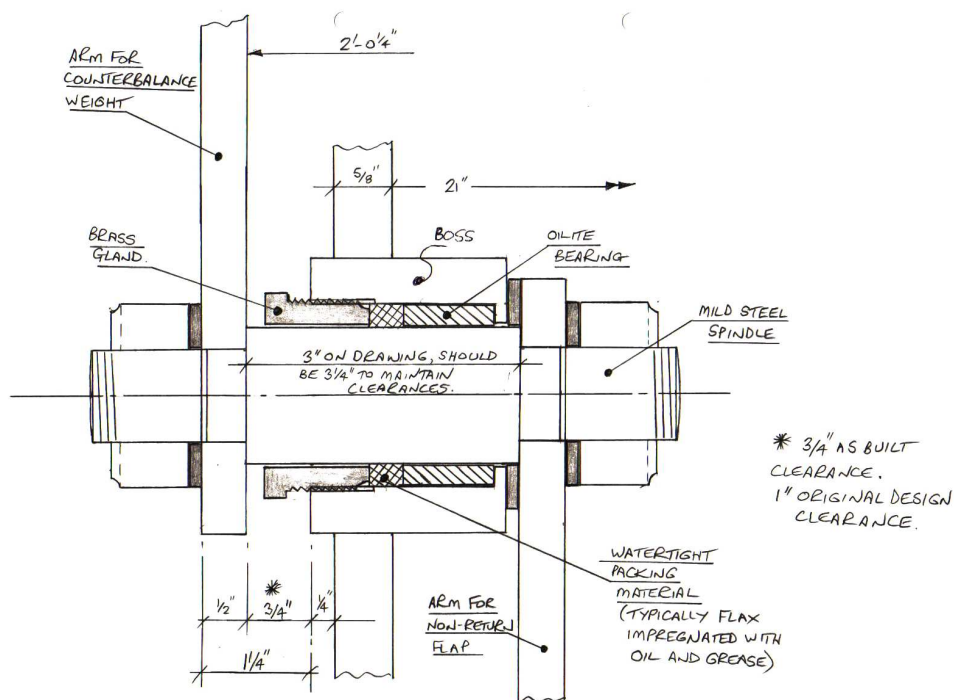
### Sketch of the hinge assembly in the duff and offal chute flap valve:

On page 2, partial copies of the flap valve hinge drawing are shown, on those copies three dimensions are indicated which are incompatible (the 3" dimension indicated on the M.S. spindle is obviously an error). The hinge has been redrawn below and it may be seen that the clearance between the end of the boss (and brass gland) and the counterbalance arm has been reduced by  $\frac{1}{4}$ ".

With the clearance as originally designed, the brass gland would be capable of being fully unscrewed without contacting the counterbalance arm. However, the error in the spindle dimension has meant that the clearance has been reduced such that if the brass gland were unscrewed it would come into contact with the arm while the threaded portion of the gland remained in the thread of the boss.

\*The dimension marked with an asterisk in this drawing ( $\frac{3}{4}$ " ) is fixed by the dimensions of the steel spindle. This dimension should have been 1".
