The stability of the trawler Gaul

Trawler Gaul *ex Ranger Castor*

Built in 1972 by Brookes Marine, Lowestoft
for Ranger Fishing, North Shields
Capsized and sank in the Barents Sea in
February 1974 with all 36 crew onboard

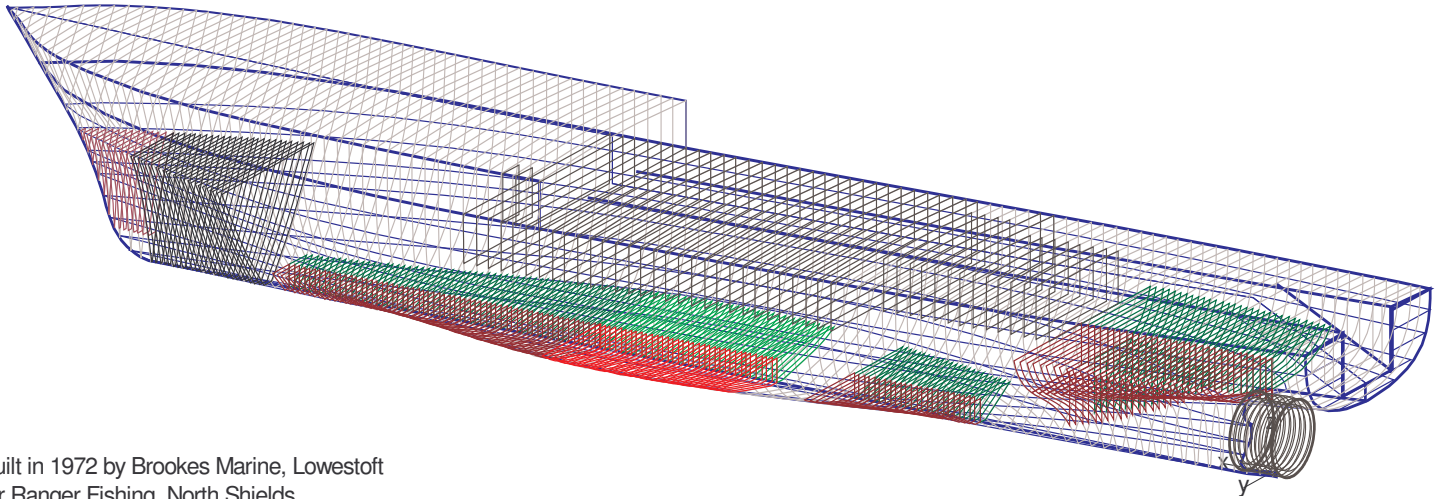
Stability model including hull, steering nozzle, tanks and factory space

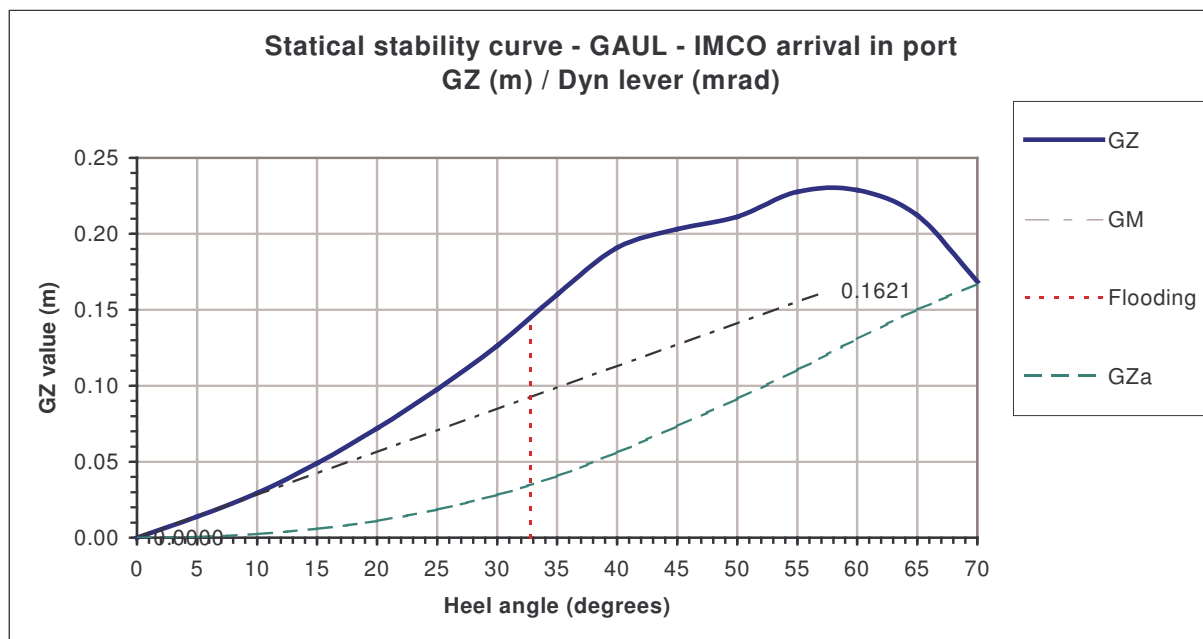
- IMCO arrival in Port (10% fuel, stores etc and 20% of fish catch onboard)

Gaul arrival in port – 34.3 tonnes Fuel Oil (total) in no.2 DB tank P&S and daily service tanks

Free trim stability:		Dyn. lever	Incr. stab	Draught	Trim
Heel a (°)	Right. lever GZ (m)	GZa(0-a) (mrad)	dGZ/da (m/rad)	mld at L/2 (m)	at CL (m)
0	0.000	0.000	0.162	3.813	1.174
5	0.014	0.001	0.161	3.806	1.149
10	0.029	0.002	0.201	3.783	1.069
15	0.049	0.006	0.248	3.743	0.949
20	0.072	0.011	0.280	3.683	0.797
25	0.098	0.018	0.309	3.598	0.623
30	0.126	0.028	0.358	3.480	0.435
35	0.160	0.041	0.415	3.319	0.245
40	0.191	0.056	0.223	3.106	0.051
45	0.203	0.073	0.084	2.838	-0.098
50	0.211	0.091	0.147	2.497	-0.158
55	0.228	0.110	0.125	2.050	-0.088
60	0.229	0.131	-0.096	1.476	0.090
65	0.212	0.150	-0.315	0.707	0.395
70	0.169	0.167	-0.708	-0.430	0.985
GZ max at 57.8°	0.231				
Minimum stability criteria:		Actual value / Compliance	Max KG' (m)	Critical Points :	Subm.angle(°)
GZa(0.0°-30.0°)>0.055mrad		0.028 / NO	5.687	Duff chute Factory entrance	32.8 55.6
GZa(0.0°-40.0°)>0.090mrad		0.056 / NO	5.753		
GZa(30.0°-40.0°)>0.030mrad		0.028 / NO	5.891

GZ(>30.0°)>0.200m		0.231 / OK	5.950		
a(GZmax)>30.0°		57.8 / OK	6.108		
GMo>0.350m		0.162 / NO	5.722		
Sum. Compliance, max KG' :		NO	5.687	Min.angle :	32.8

The table above shows that the vessel fails to meet four of the IMCO's six minimum stability criteria (i.e. the GZ areas and the initial GM value) in the given sailing condition and that the failure is neither marginal nor borderline, but a failure by a substantial margin (see differences between minimum stability criteria and the actual values).
