m.f.v. Trident (ON PD111)

Report of Court No. S 497

Formal Investigation

m.f.v. TRIDENT

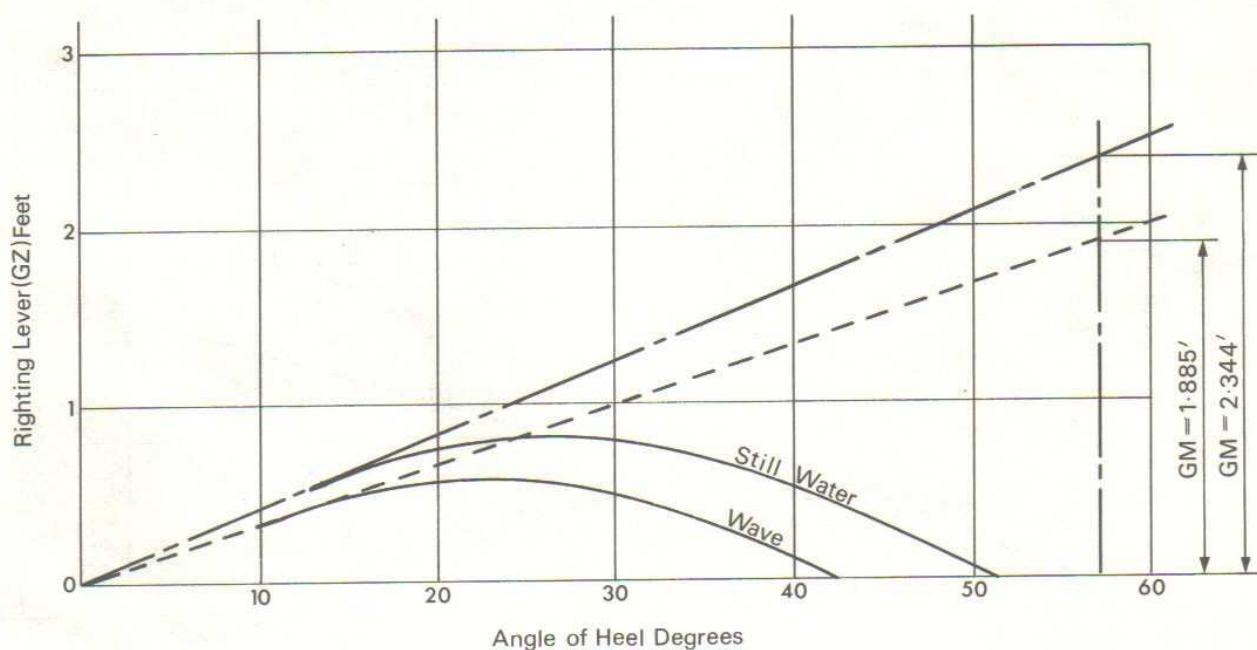
A1 Trident

Estimated condition at time of loss
5 tons fuel oil

In Still Water	On Crest Of Wave
15.88 ft. deg.	11.74 ft. deg.
22.40 ft. deg.	14.83 ft. deg.
6.52 ft. deg.	3.09 ft. deg.
0.818 ft. @ 25°	0.574 ft. @ 22°
0.792 ft.	0.476 ft.

Hydrostatics based on lines plan prepared by
Bute Slip Dock Company

Assumed wave height 13.0 ft. length 230 ft.
of trochoidal form.

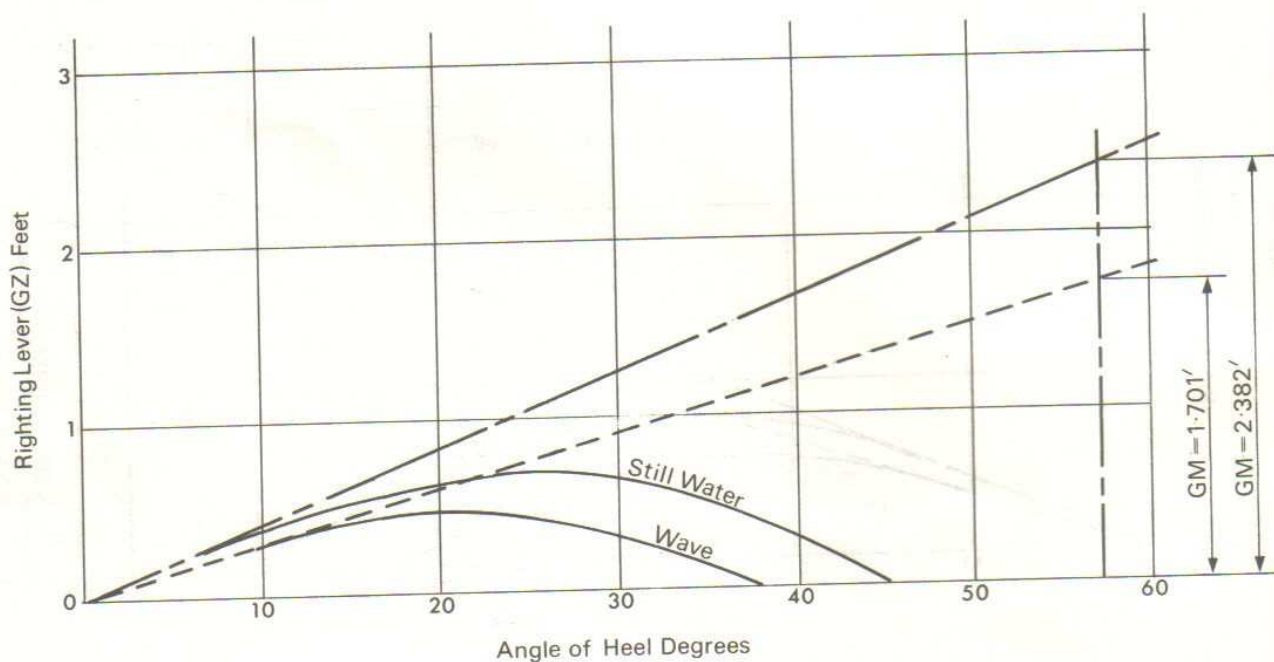
A2 Trident

The best approximations that can be made of *Trident's* stability are set out in a production which is copied as an Appendix hereto. They show (A.2) that on the less favourable assumption that *Trident* had only five tons of fuel

remaining and using hydrostatics based on measurement of the hull of *Silver Lining* (in place of those deduced from the builders' lines plan) *Trident* failed to comply with IMCO minima in three respects: area 30 - 40°, maximum GZ position, and GZ at 30° (in the last case the deficiency was marginal). In the remaining three criteria, *Trident* was substantially in excess of IMCO recommendations. Conflicting views were expressed in evidence on the conclusion to be drawn from these results. Mr James Donaldson, Ship Surveyor in the Department of Trade's Marine Survey Office in Aberdeen, and a Fellow of the Royal Institution of Naval Architects, considered that *Trident's* stability (on these figures) complied 'substantially' with IMCO. A contrary opinion was expressed by Mr M J Napier, a Consultant Naval Architect with particular experience in the design of fishing vessels. Despite the very great weight which must be given to a witness of such high qualifications, experience and obvious ability as Mr Donaldson, the Court prefers Mr Napier's view on this matter. The IMCO standards are expressed as minima and it has recently been observed that they may require to be raised and that this has in fact been done in Poland and USSR (Holland-Martin Report on Trawler Safety 1974: Appx D para 11 p 139). Assuming that the conventional GZ (or righting-lever) curve is a valid measure of stability, the deficiency in *Trident* started to become significant at about the angle of heel at which her bulwark rail became submerged and was critical in the assumed situation at the time of the casualty. The Court is advised that the GZ curves drawn out from the available data indicate too rapid a decline in righting moment at this and greater angles of heel. It must be acknowledged that the data used in this study may be inaccurate — but any error may lie in either direction. The Court is further advised that the configuration of the curves as a whole is unsatisfactory: indicating that *Trident's* design fell below accepted standards of stability. The importance of this in the case of a trawler designed for the difficult waters of the Scottish fishing grounds is obvious. It does not appear to the Court or to the Assessors to be justifiable to 'set off' deficiencies in some respects against surpluses in other respects. The frequency with which a critical position is reached may be reduced: but that does not assist the vessel when such a position is reached.

Estimated condition at time of loss
5 tons fuel oil

In Still Water	On Crest Of Wave
14.09 ft. deg.	9.45 ft. deg.
19.02 ft. deg.	10.71 ft. deg.
4.93 ft. deg.	1.26 ft. deg.
0.691 ft. @ 24°	0.469 ft. @ 20°
0.643 ft.	0.29 ft.

Hydrostatics based on lines plan prepared by
Napier Company from measurements lifted
from hull of sister vessel *Silver Lining*

Assumed wave height 13.0 ft. length 230 ft.
of trochoidal form.
