Comparisons and toggles

Maritime casualty investigation

Some similarities and disparities in the public inquiries into the losses of the MV Derbyshire and FV Gaul are given below. The possibilities that important evidence was withheld and misleading evidence given during the Gaul RFI, are also discussed.

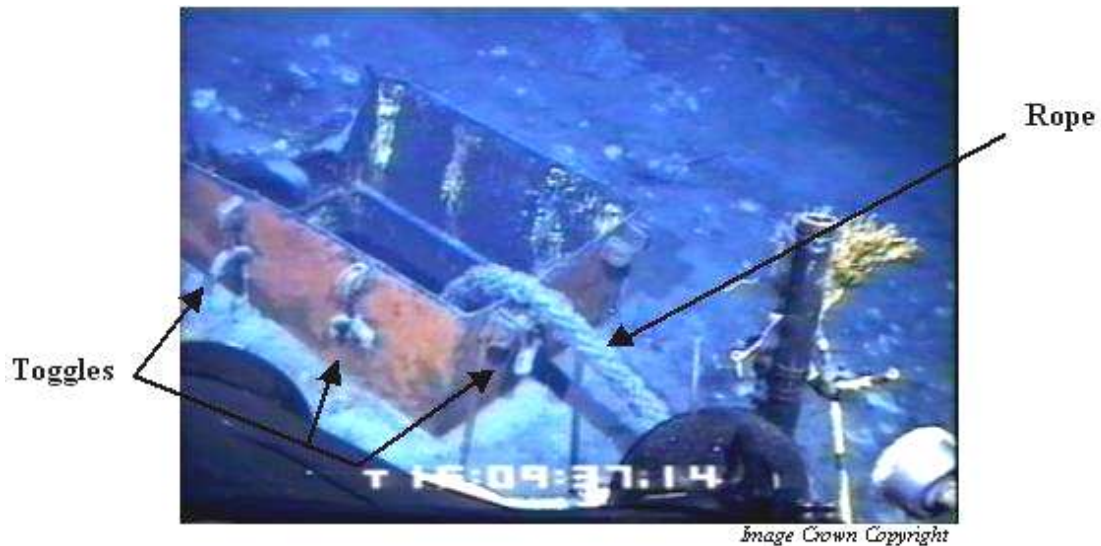
The teams of experts assigned to each of the investigations argued that unsecured weathertight hatch lids were the root cause of both tragedies. They further argued that a rope emerging from the Bosun's store hatch opening on the Derbyshire and a ligature or rope holding back the duff chute's inner lid on the Gaul provided important proof of crew negligence. (A brief chronology and a number of further similarities are recorded in appendix 1)

Derbyshire - unsecured hatch to the Bosun's store

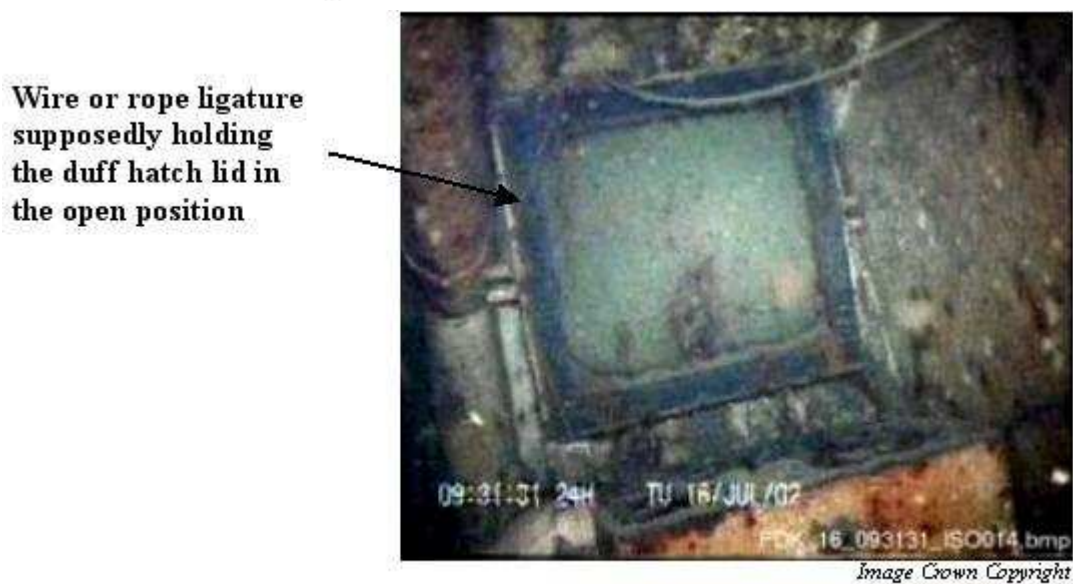
Gaul - unsecured inner cover to the Duff chute

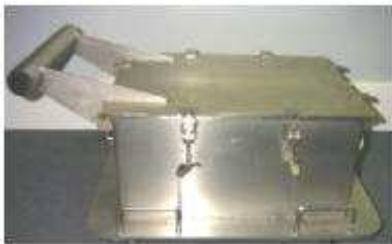
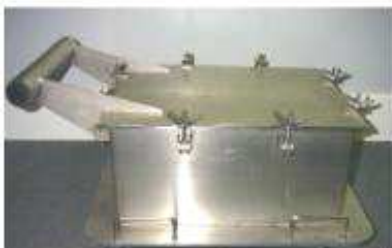
A model of the weathertight hatch cover for the Bosun's store on the Derbyshire, this was constructed to assist the court with their deliberations during the 2000 Formal Investigation

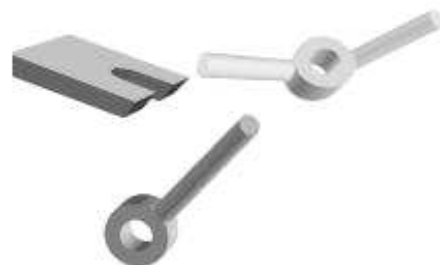
Typical securing arrangements for a weathertight hatch lid are shown above - a forked lug and a securing toggle consisting of a swing bolt and butterfly nut

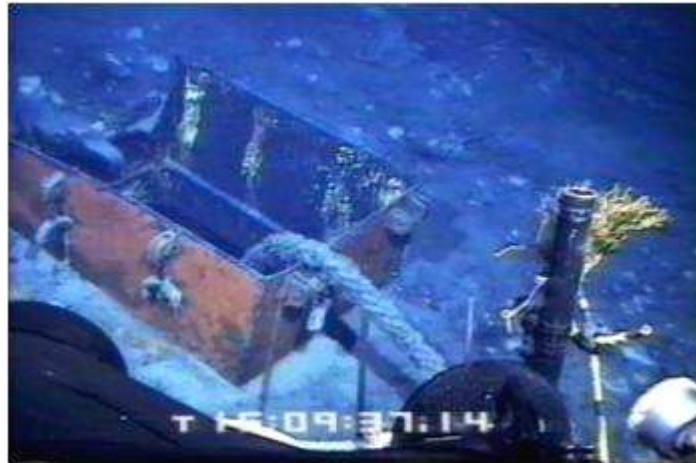
The rope seen emerging from the bosun's hatch opening and the disposition, position and condition of the hatch toggles was deemed by the Derbyshire's expert Assessors to provide firm evidence that the crew had neglected to secure the hatch lid prior to the storm in which she foundered.

“.....there was strong evidence that such hatches on the DERBYSHIRE and some of her sister ships suffered from a design defect in as much as the toggles tended to loosen and ride down their shanks with the working of the vessel in the seaway.”

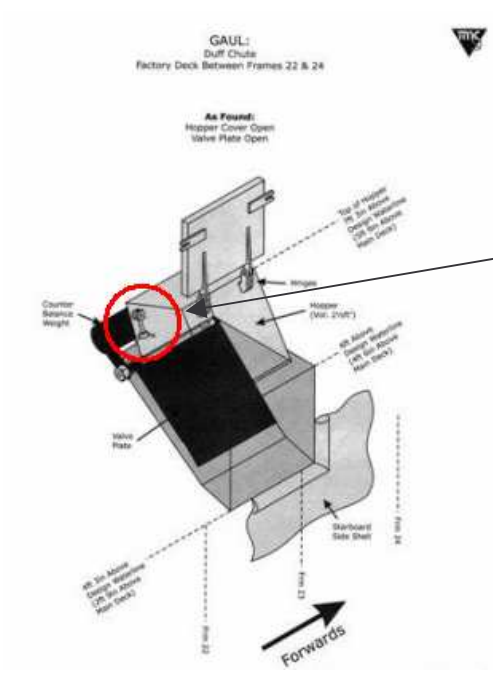
Duff chute: the toggle in this ‘as found’ drawing is shown to be at repose when in fact the image from the previous page has indicated that it was actually sitting at an angle of 105° to its normal position of repose (vertical)

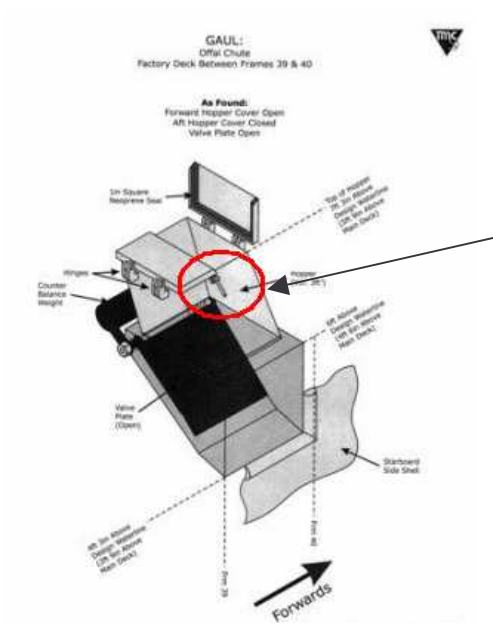
Offal chute: The toggle in this ‘as found’ drawing is shown to be at repose, and the butterfly nut is missing, the image shown on the previous page has however, indicated that the toggle (as found) was in fact in an upright vertical position with its butterfly nut fitted in place

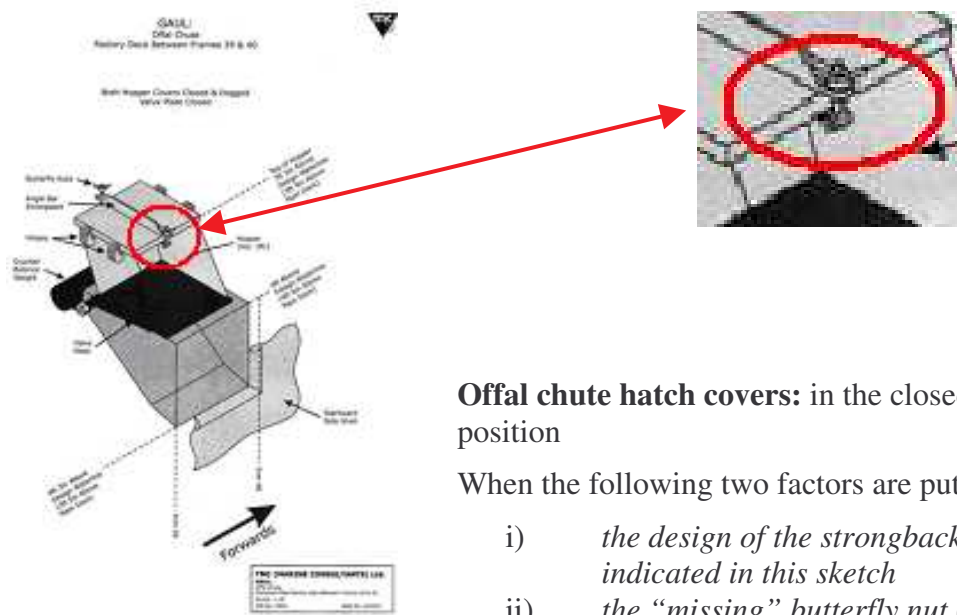
Offal chute hatch covers: in the closed and secured position

- i) *the design of the strongback bar end, as indicated in this sketch*
- ii) *the “missing” butterfly nut (as indicated in the experts “as found” sketch on the preceding page)*

However, the strongback bar was not arranged in this way and the butterfly nut was still attached to the toggle bolt
