# The Trawler Gaul

# **Some comments on the loss of the trawler Gaul and the re-opened Formal Investigation**

**REPORT OF THE RE-OPENED FORMAL  
INVESTIGATION INTO THE LOSS OF  
THE FV GAUL**

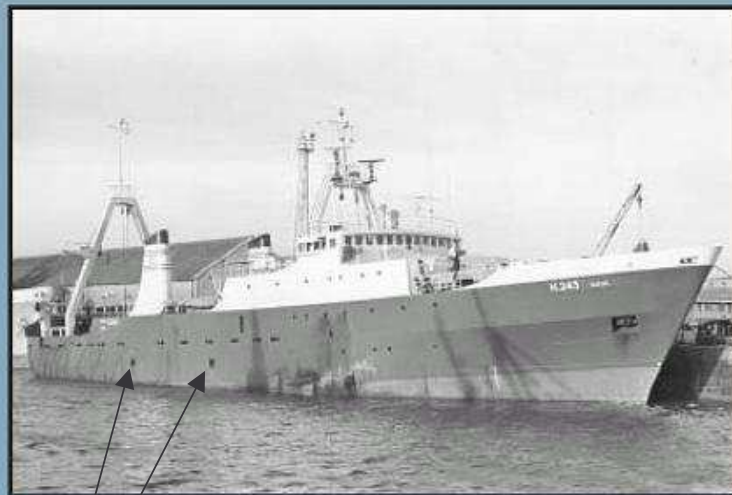
Duff and offal chute openings

- 2.48 The design was apparently simple and use of the hoppers should have been straightforward (albeit that the height of the rim of the hopper at 5 ft 10 inches above the deck might have been somewhat high). But an annotation on the drawing states that the design of the watertight hopper hatch cover was “too fiddly”. This view was shared by the expert in this field, Mr Tanton.
- 2.49 In his view, the primary difficulty was that the design of the hinge was too elaborate for the purpose of operating the valve plate. The square machine

sections of the spindle, and the corresponding square holes in the support arms attached to the underside of the valve plate and in the balance weight connecting arms, would eventually wear round due to the repeated impact of the valve plate with the lower part of the chute, effectively disconnecting the balance weight from the valve plate. In any event, it was notable that there was no grease nipple. Yet the use of mild steel for the hinge spindle in a highly corrosive atmosphere would have inevitably resulted in corrosion within the brass gland. Furthermore, it is not clear how the spindle could have been repaired or replaced should the need arise without burning off the balance weight from the connecting arms (something that was found to have been done on the sister vessel Kappin [formally Arab] by representatives from the Inquiry when inspected in 2003).

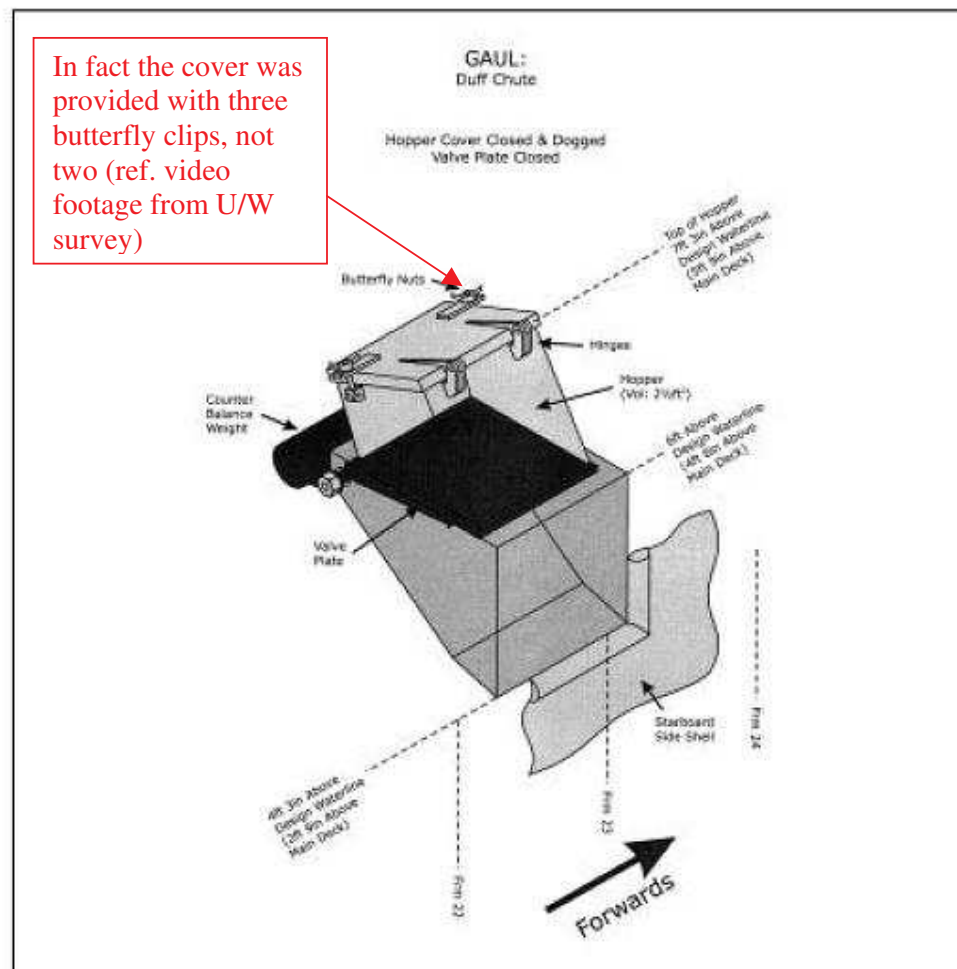
- 2.46 During the RFI, an attempt was made to correct the calculations by accounting for the weight of the valve plate, albeit no clear dimensions of the valve plate could be found. The conclusion was that, ignoring any friction on the hinge, the approximate weight required in the hopper to open the valve plate would have been about 35 lbs which is about 0.5 cubic feet of waste.

- 2.47 Fish waste and other material would be collected in plastic 84 lb baskets from the deck, Turo pump sumps and from the sorting conveyor. Duffs would be

chopped up by a shovel and collected in similar baskets. This material would then be dumped from time to time through the chutes.
