MV Derbyshire - theories and factual evidence

Bulk Carriers and the Derbyshire

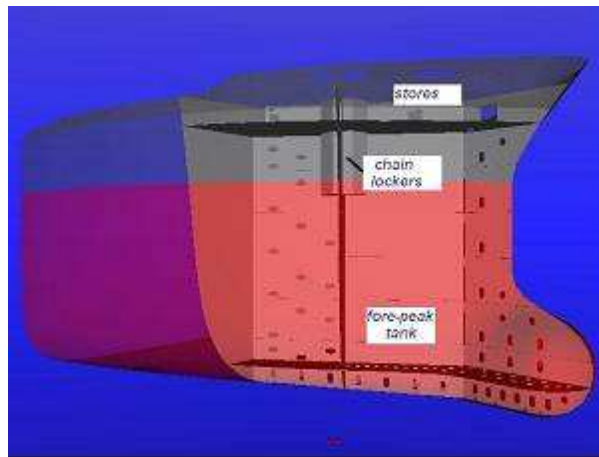
However, the MARIN model tests, which indicated that hatch failure was a realistic possibility, were carried out for two principal conditions only – with the vessel in undamaged and fully damaged conditions. In the fully damaged condition, in addition to the store spaces and the ballast tank, the forward fuel oil deep tank was also assumed flooded⁴ - i.e. with some 3000 tonnes of seawater in addition to the 2000 tonnes of fuel oil it initially contained. In this condition the vessel's trim would have been approximately double that of when the stores and forepeak ballast tank only were flooded.

Bearing in mind that the fuel tank was not flooded prior to hatch cover failure, it would have been more appropriate if the MARIN model tests had been carried out with the model in a condition that reflected that situation. The fact that these MARIN results were subsequently used in a process of statistical analysis and extrapolation does not automatically give confidence in the final outcome of this whole modeling process.

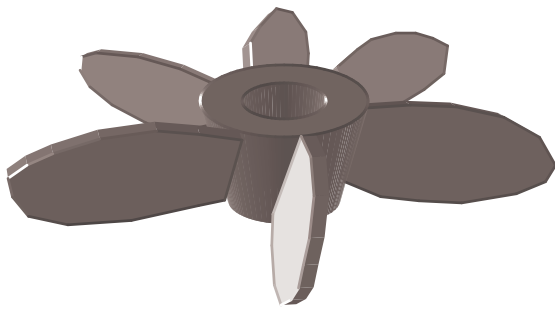
An old newspaper article, published more than 100 years ago in the New York Times, and which is copied below may be able to give us a lateral view of what might possibly have happened onboard the MV Derbyshire that day in September 1980.

On Jan. 11 a gale came up out of the west and the vessel pitched heavily. Early in the morning Capt. Creeden, the skipper of the *Elsie*, was alarmed by a great din coming from the interior of his vessel. There he found that three of the blades of the propeller had broken off. The men were kept on a continual hop-skip-and-jump to dodge the ponderous masses of metal thrown about by every pitch of the ship. To make bad worse, the huge tail shaft gave indications that it, too, was about to break loose. To secure the shaft was the main object, and it was attained after many narrow escapes in dodging the propeller blades.

The "jamboree," as the Captain called it, of the propeller lasted half an hour, but it will cost the owners considerably over \$4,000 to repair damage.

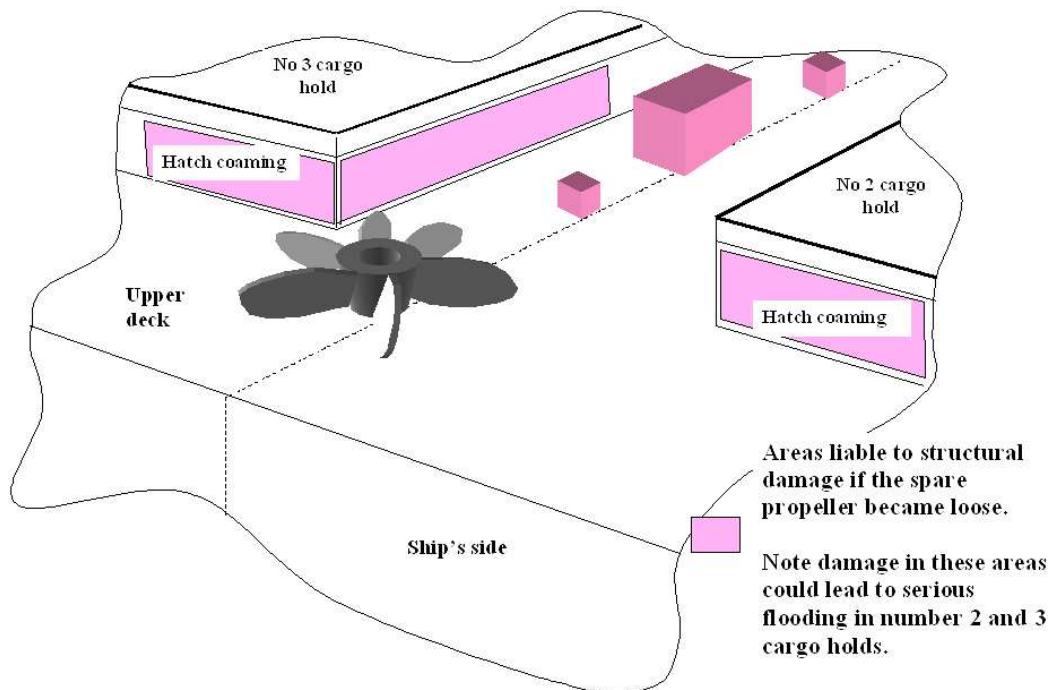
If the spare propeller became detached from its supports, apart from the possibility of it sliding overboard, there would also be the possibility of it travelling inboard as well as fore and aft, due to the vessel's pitch and roll motions and the actions of storm force waves breaking over the fore deck.

If the spare propeller *did* travel inboard, the hatch coamings, which were nearby, together with several small access hatches and the companion house, which led to the number 2 and 3 holds, would be liable to serious damage. The 41 tonne propeller would find little resistance, should it come up against any of these small deck structures; similarly, the

blades of the propeller would be able to punch through and gash holes into the hatch coamings with relative ease
