# DESIGN ERROR 1

## The construction and arrangement of the duff chute:

### A false premise

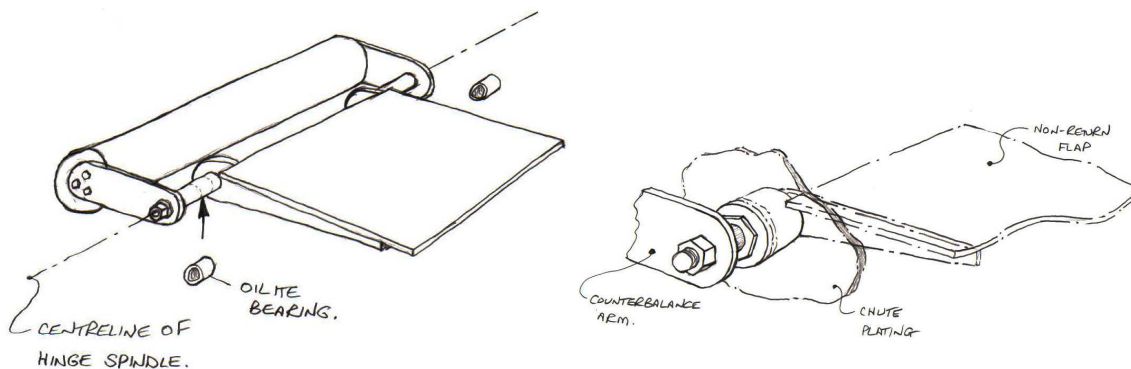
Sketches showing the internal moving parts in the duff chute: the flap valve, the spindles, the counterbalance weight and arms:

The information on the following pages shows only one of a number of possible failure mechanisms that could have led to the valve flaps being open at the time of the vessel’s loss. This failure results from a simple **design error** on the shipyard drawing.

There was a dimensional error on the shipyard’s construction drawing for the duff and offal chute valve flap hinge assembly in that the length of the median portion of the spindle should have been 3¼” instead of only 3”, as the design prescribed. (for further information on this point see the part prints below and Annex 1) this dimensional error only becomes apparent when the distance between the two counterbalance arms (indicated to be 2’-0¼” on the drawing) is matched against the sum of the dimensions of the parts between the counterbalance arms and the position of the hinge spindles, which was fixed. Although the effect of this error would not have appeared as significant at the time of assembly, it would have reduced the clearance between the end of the brass glands and the steel counterbalance arms, making it insufficient.
