The stability of the trawler Gaul

Trawler Gaul *ex Ranger Castor*

Built in 1972 by Brookes Marine, Lowestoft
for Ranger Fishing, North Shields
Capsized and sank in the Barents Sea in
February 1974 with all 36 crew onboard

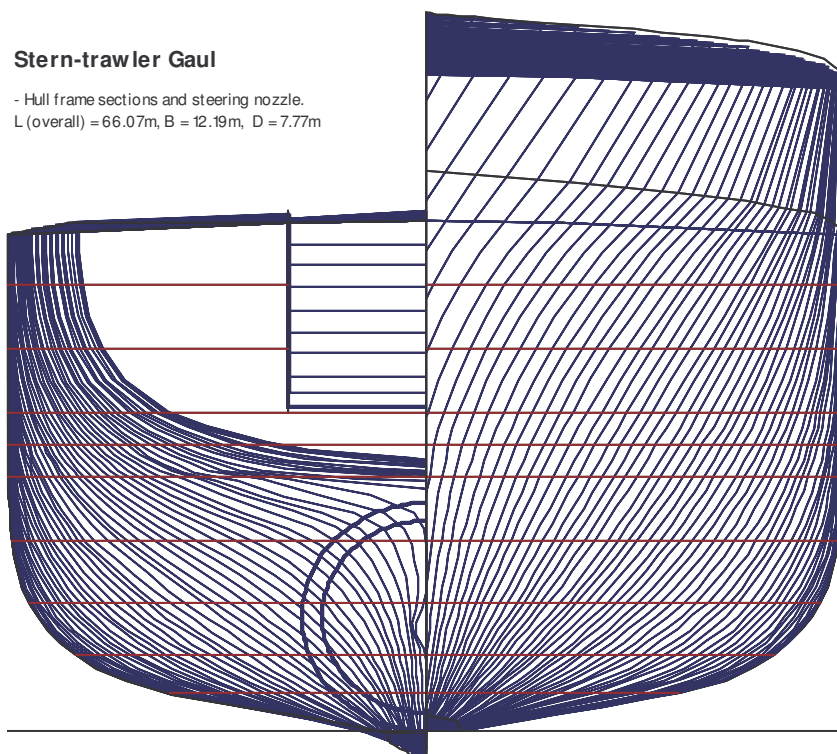
Added to that, and most important of all, was the fact that, shortly after her delivery, the Gaul's owners converted two of her double bottom tanks to enable them to carry fuel oil instead of ballast water (ballast water was required on the Gaul to ensure that the vessel could maintain adequate stability in all anticipated sailing conditions), but the stability documents were not revised to take account of this significant modification.

The effects of this alteration could only be described as disastrous from the viewpoint of the Gaul's ability to meet the IMCO stability standards (*see example in Annex I*) and, in fact, on the day of her loss it is probable that, unbeknownst to her skipper, she was sailing in a marginal or deficient stability condition³.
